Equipment Report

Report No :		ACR190219-01 Rev1	
Address:		Research School of Chemistry ANU	
Prepared & Approved By :		B.Williams LAA000169

Date:		June 2019	
Re-inspection Due		June 2020

ACR was engaged to undertake an inspection of equipment at the Research School of Chemistry ANU that was suspected to have asbestos containing materials present.

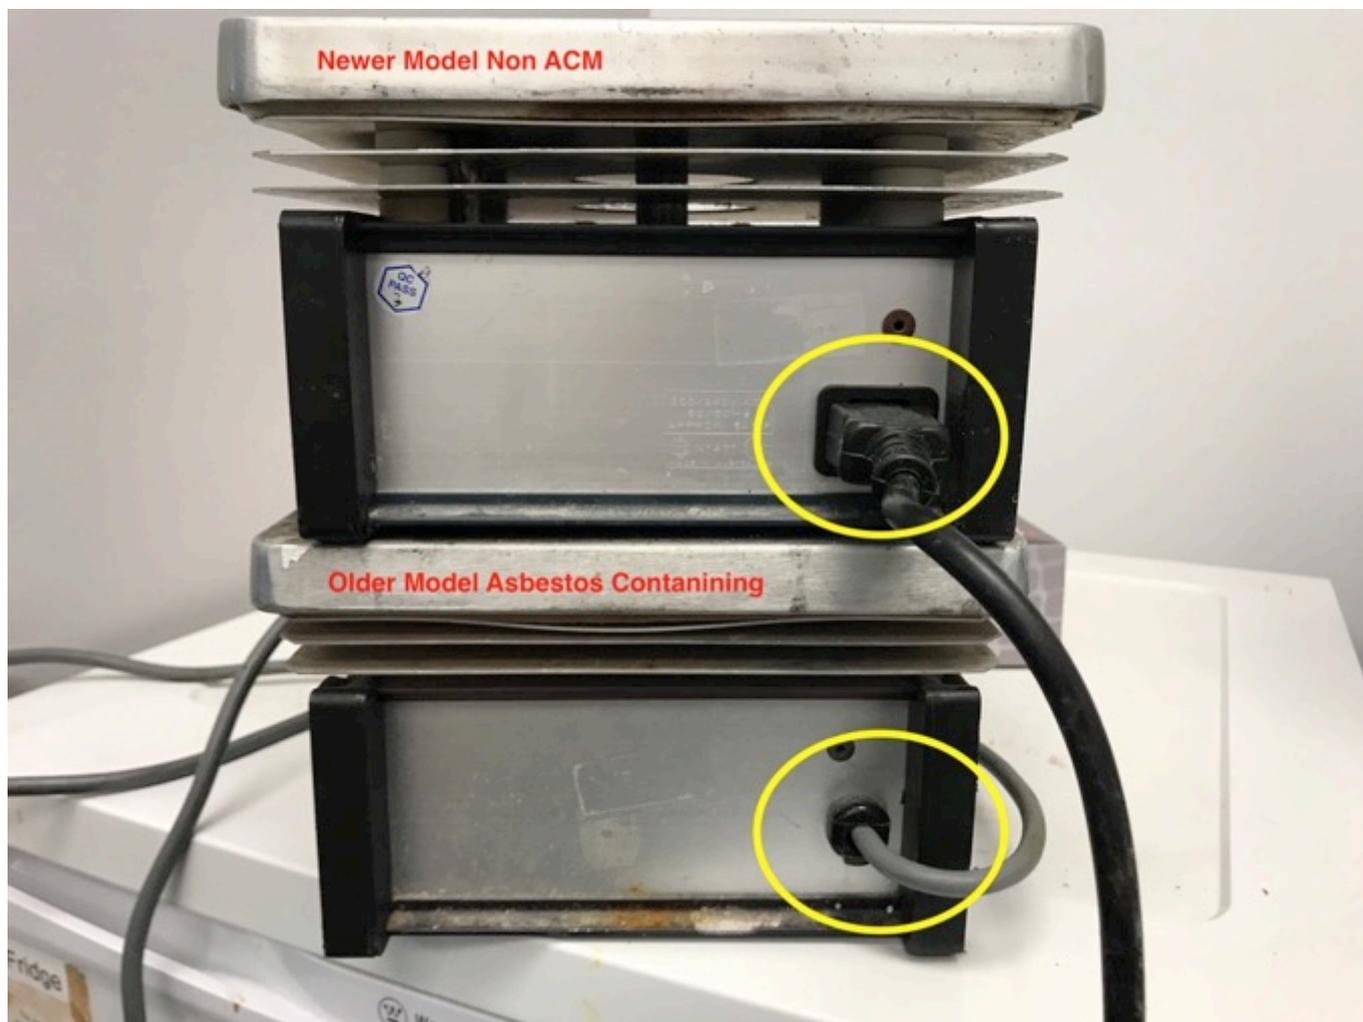
During the inspection RSC Technical staff took the IEC Heater Stirrers that had a fixed power cable & were the older models away for disposal. (See Photo below)

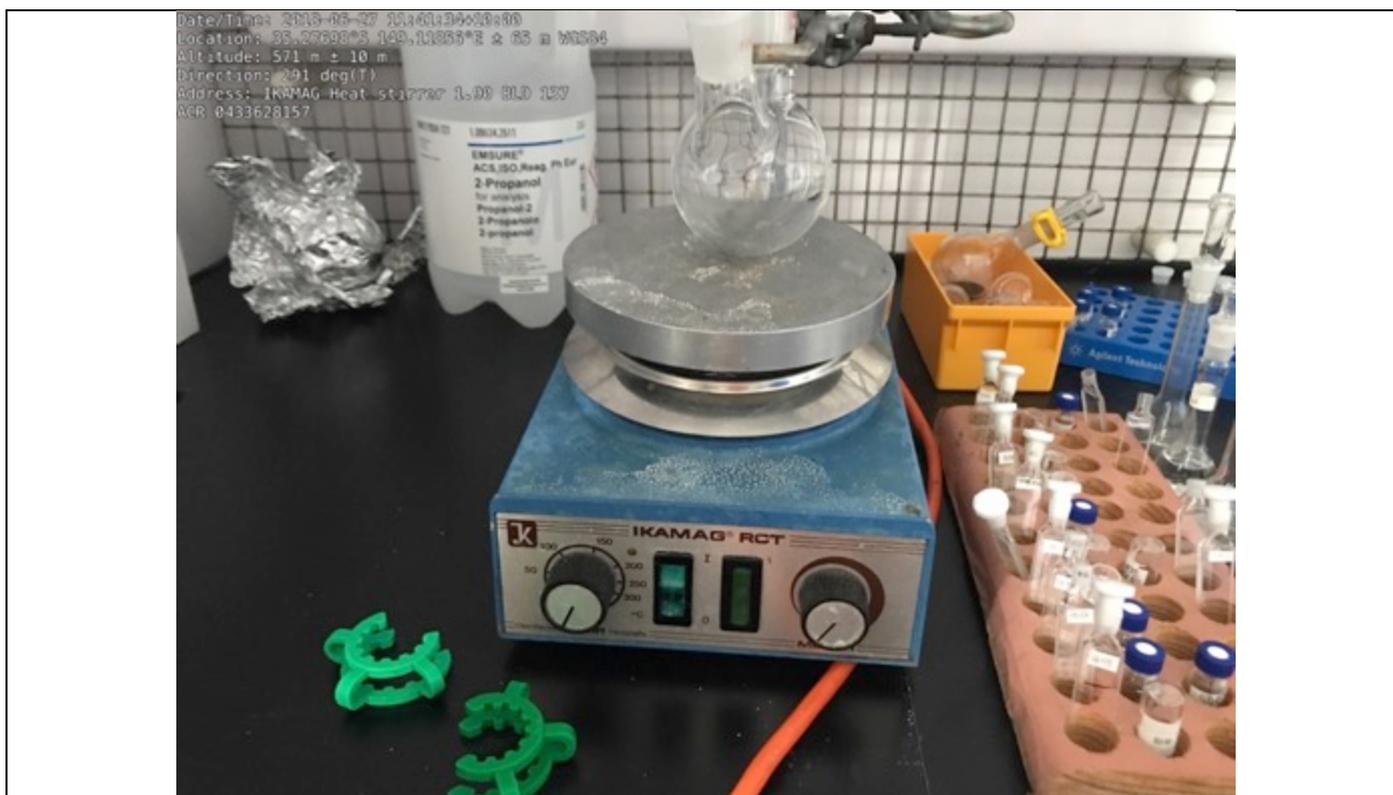
Room 1.90	IKA Heater Stirrer	-	Good	Visual	3
-----------	--------------------	---	------	--------	---

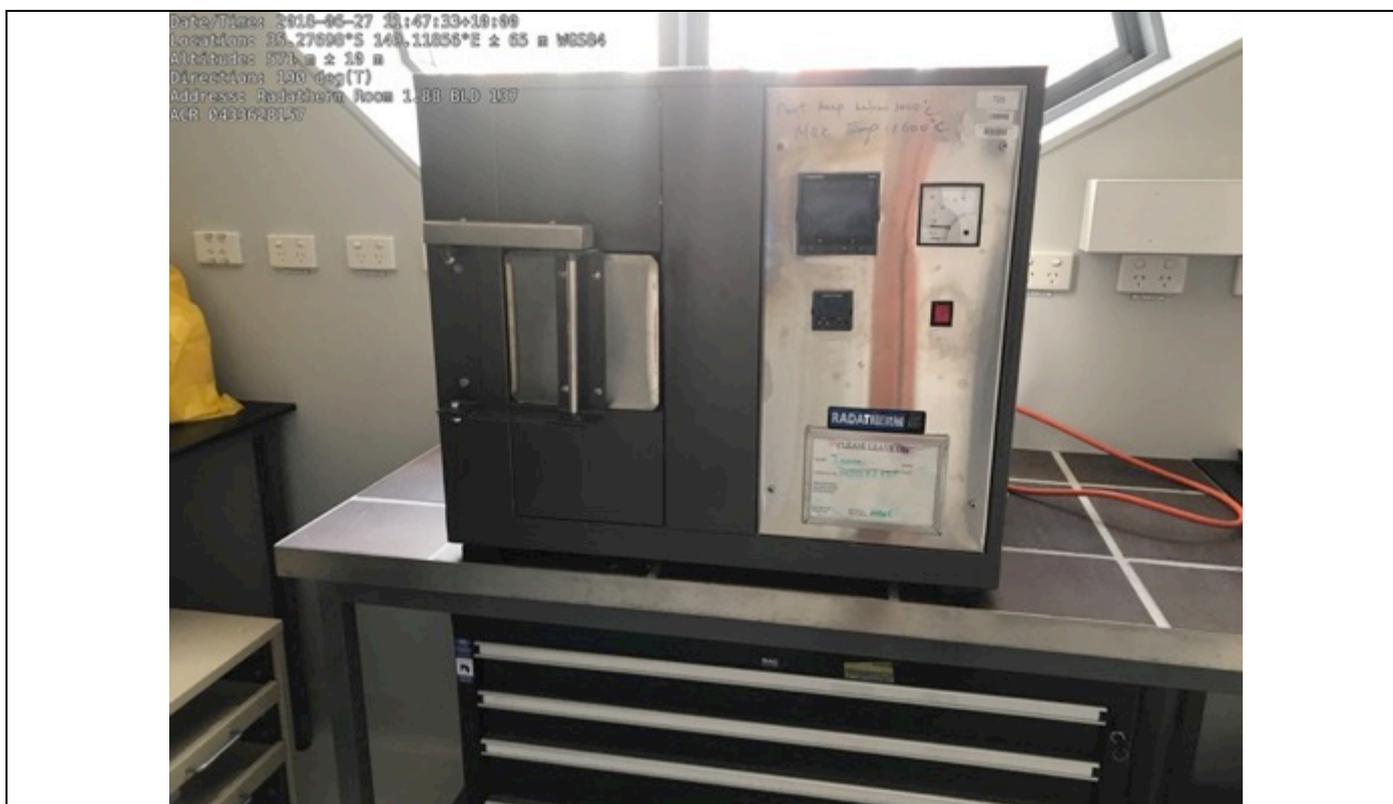
Room 1.88	Radatherm Oven	-	Good	Visual	3
-----------	----------------	---	------	--------	---

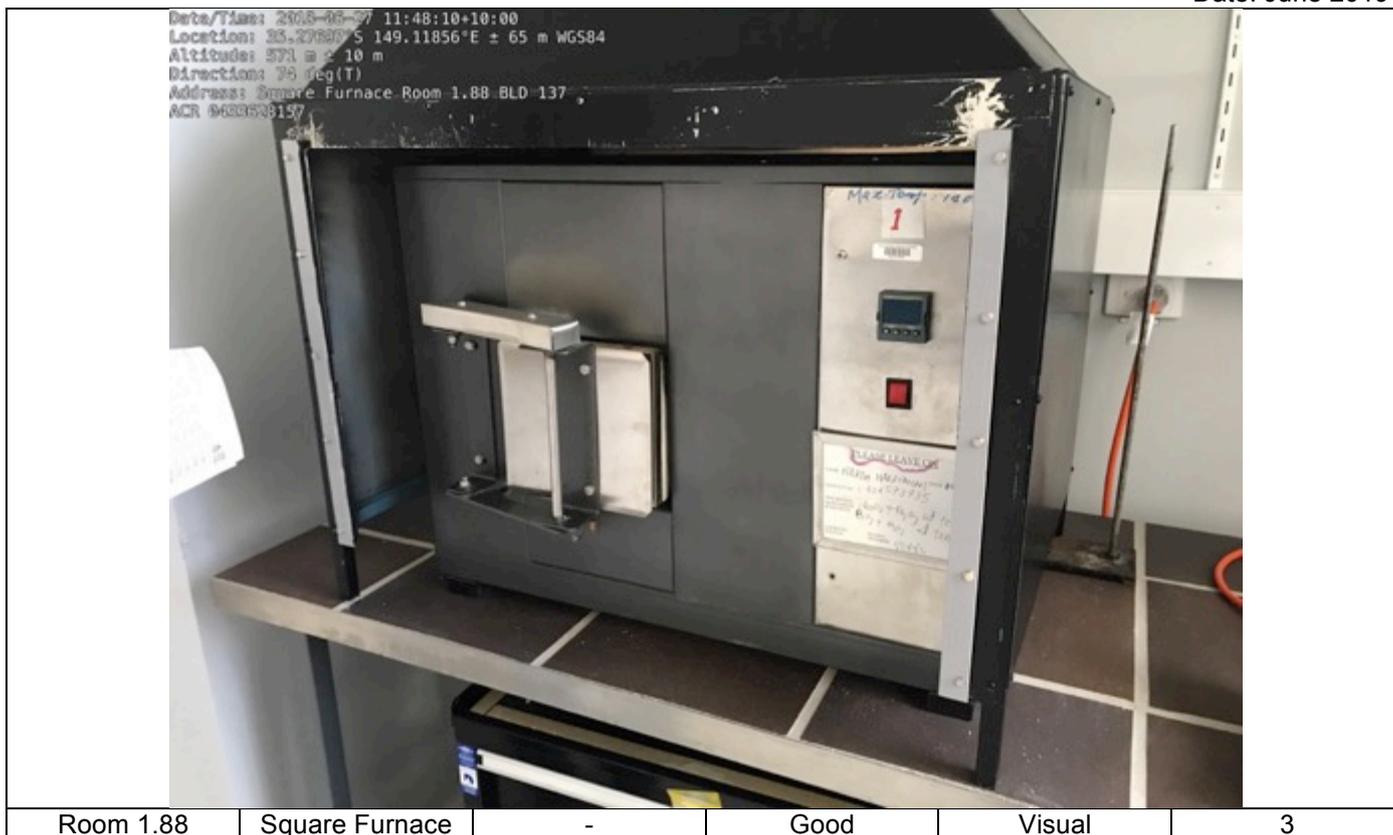
Room 1.88	Square Furnace	-	Good	Visual	3
-----------	----------------	---	------	--------	---

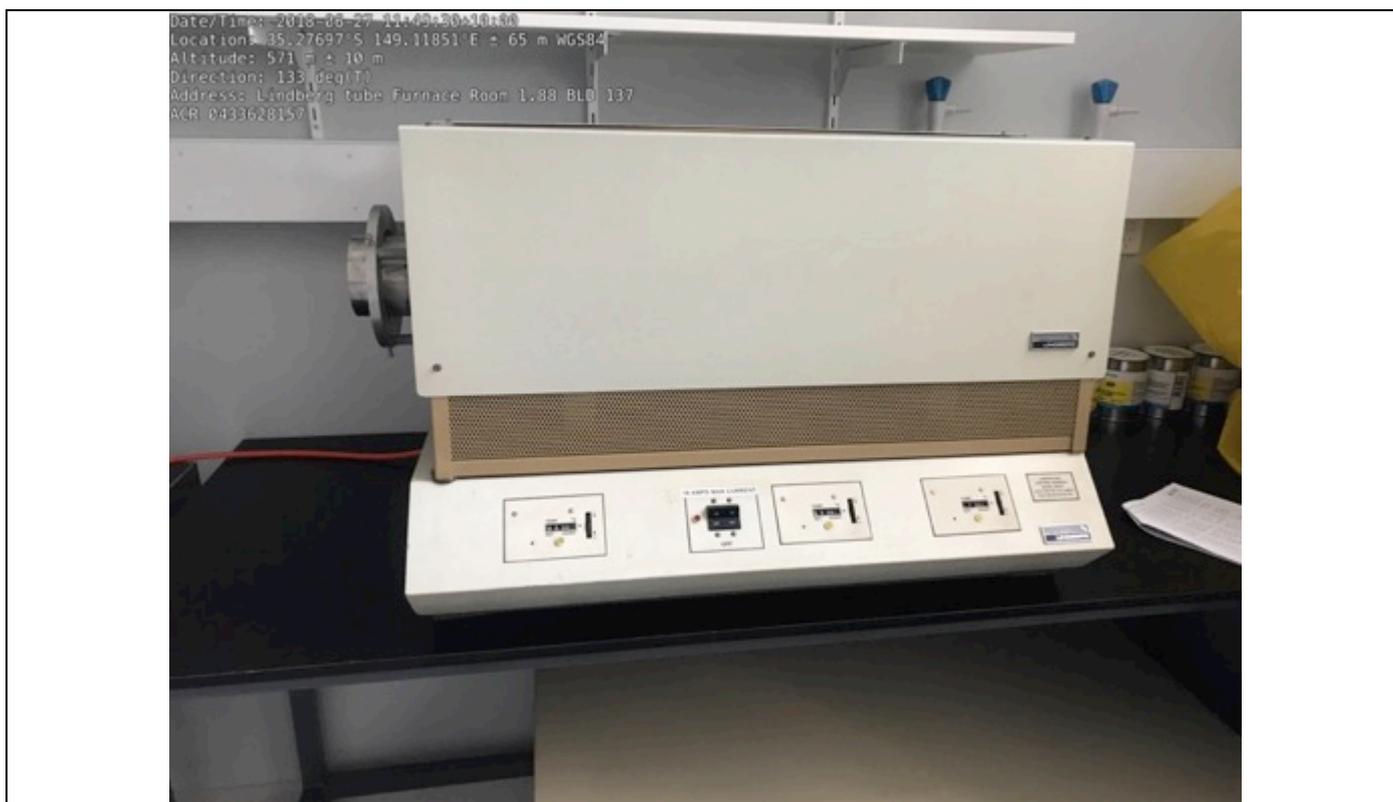
Room 1.88	Lindberg Tube Furnace	-	Good	Visual	3
-----------	-----------------------	---	------	--------	---

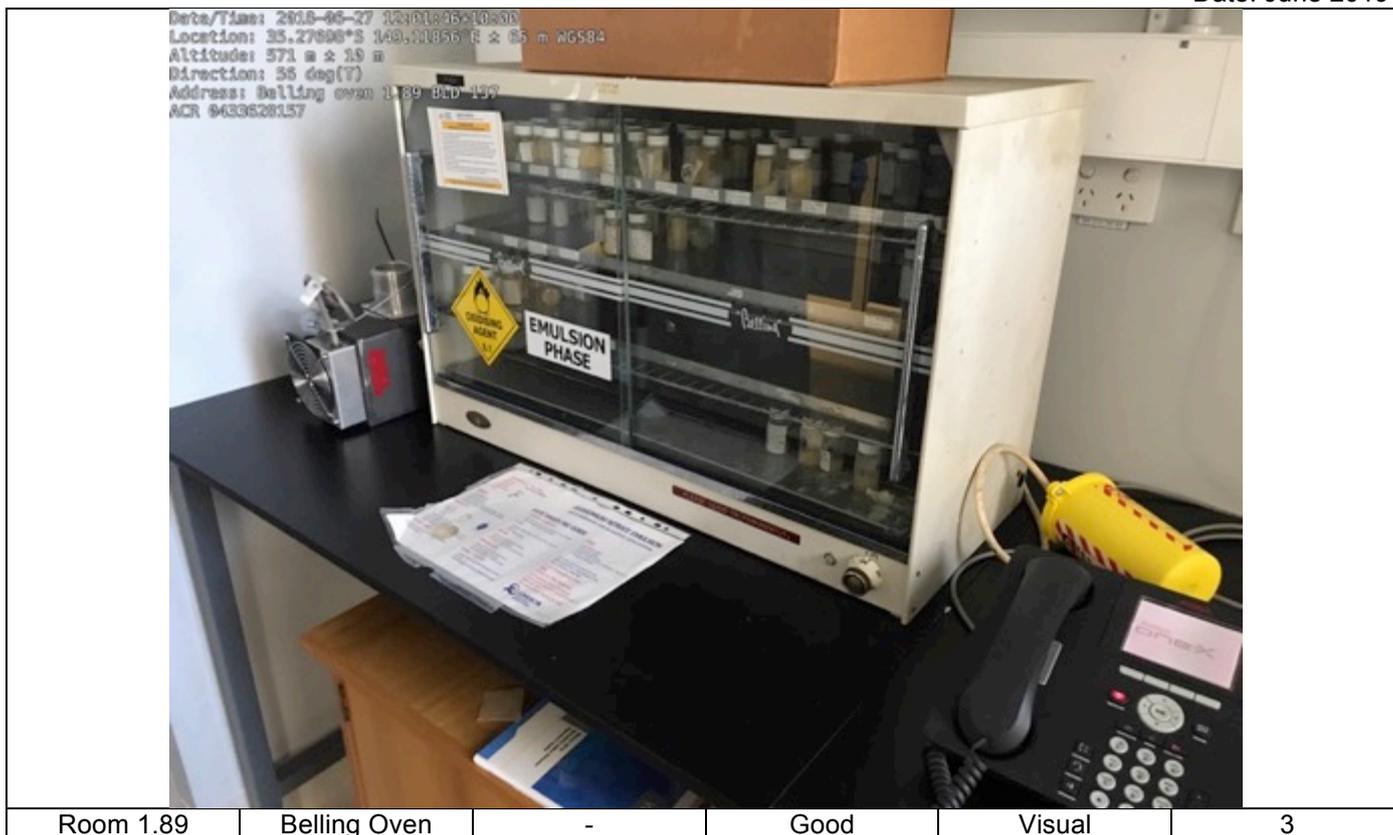
Room 1.89	Belling Oven	-	Good	Visual	3
-----------	--------------	---	------	--------	---

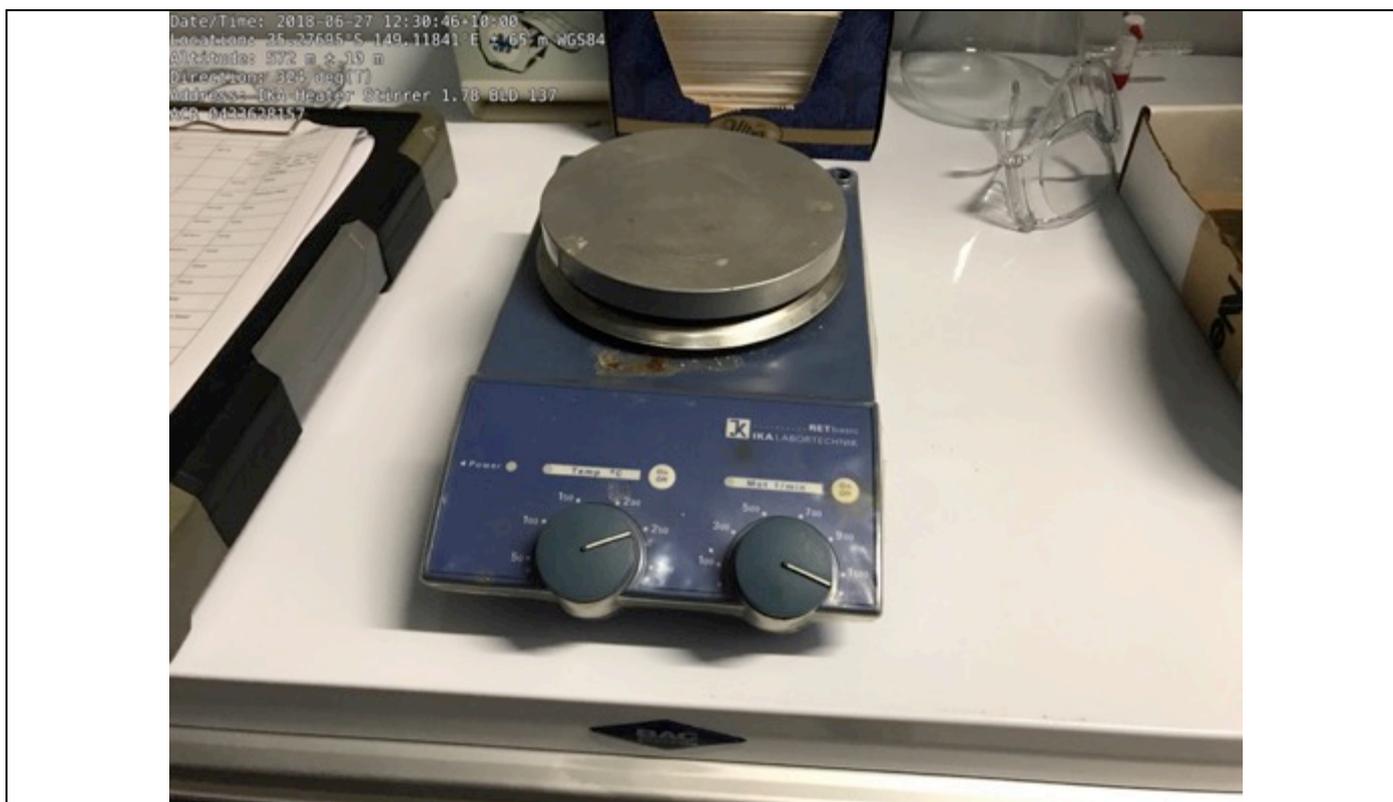
Room 1.78	IKA Heater Stirrer	-	Good	Visual	3
-----------	--------------------	---	------	--------	---

Room1.78	IKA Heater Stirrer		Good	Visual	3	Yes	<p>No visual ACMs present during standard usage.</p> <p>Due to the age & type of equipment it should be assumed that ACMs are present in the unit.</p> <p>Any personnel conducting repairs or maintenance should be aware that ACMs might be present.</p> <p>No works on the equipment is to proceed if it is suspected it will disturb the possible ACMs, equipment should be tagged out & disposed of accordingly by a Licensed Professional</p>
Room 3.25	PIERCE Sample Heater	-	Good	Visual	3	Yes	<p>No visual ACMs present during standard usage.</p> <p>Due to the age & type of equipment it should be assumed that ACMs are present in the unit.</p> <p>Any personnel conducting repairs or maintenance should be aware that ACMs might be present.</p> <p>No works on the equipment is to proceed if it is suspected it will disturb the possible ACMs, equipment should be tagged out & disposed of accordingly by a Licensed Professional</p>

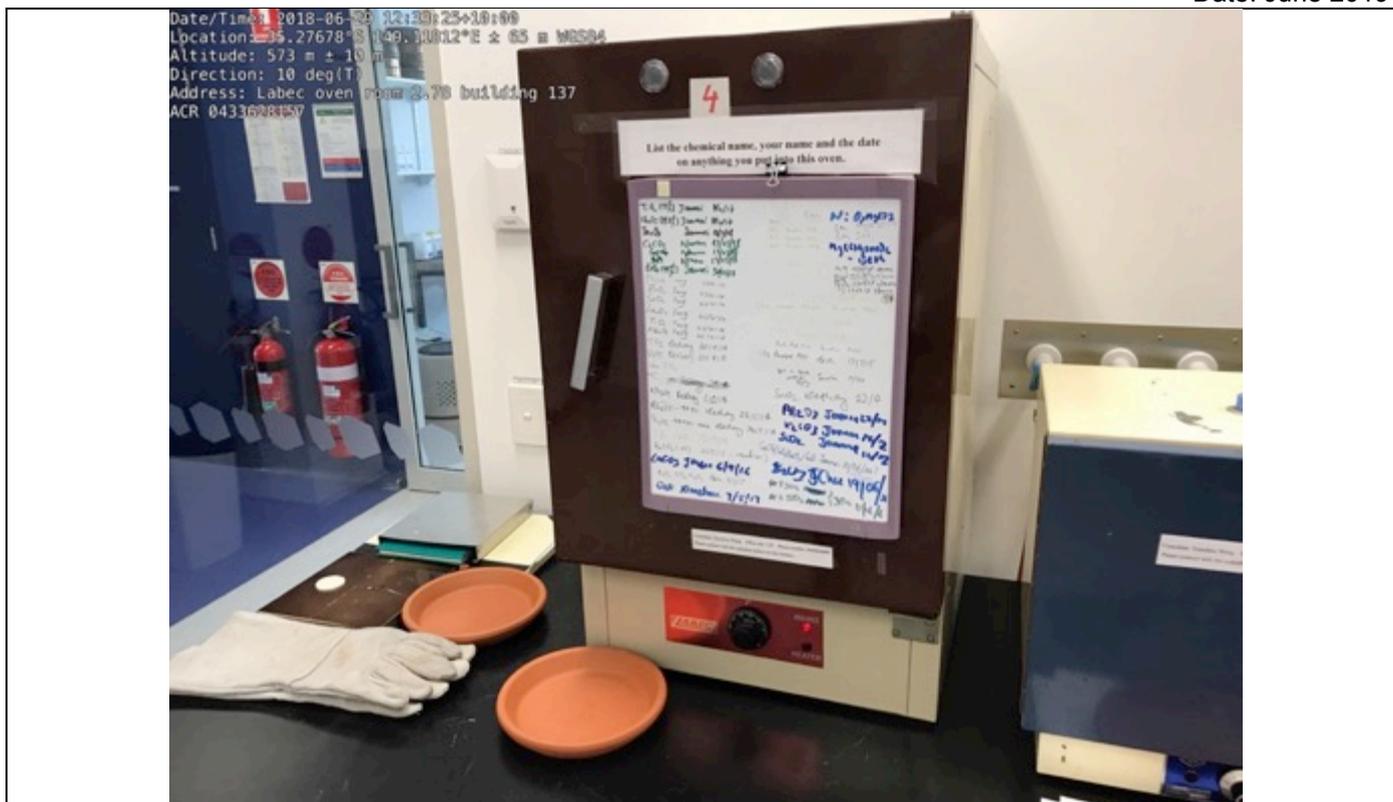
Room 2.78	Labec Oven	-	Good	Visual	3
-----------	------------	---	------	--------	---

Room 2.78	LABEC tube furnace	M782	Good	Visual	3	Yes	No visual ACMs present during standard usage. Due to the age & type of equipment it should be assumed that ACMs are present in the unit. Any personnel conducting repairs or maintenance should be aware that ACMs might be present. No works on the equipment is to proceed if it is suspected it will disturb the possible ACMs, equipment should be tagged out & disposed of accordingly by a Licensed Professional
	LABEC tube furnace	N405	Good	Visual	3	Yes	No visual ACMs present during standard usage. Due to the age & type of equipment it should be assumed that ACMs are present in the unit. Any personnel conducting repairs or maintenance should be aware that ACMs might be present. No works on the equipment is to proceed if it is suspected it will disturb the possible ACMs, equipment should be tagged out & disposed of accordingly by a Licensed Professional

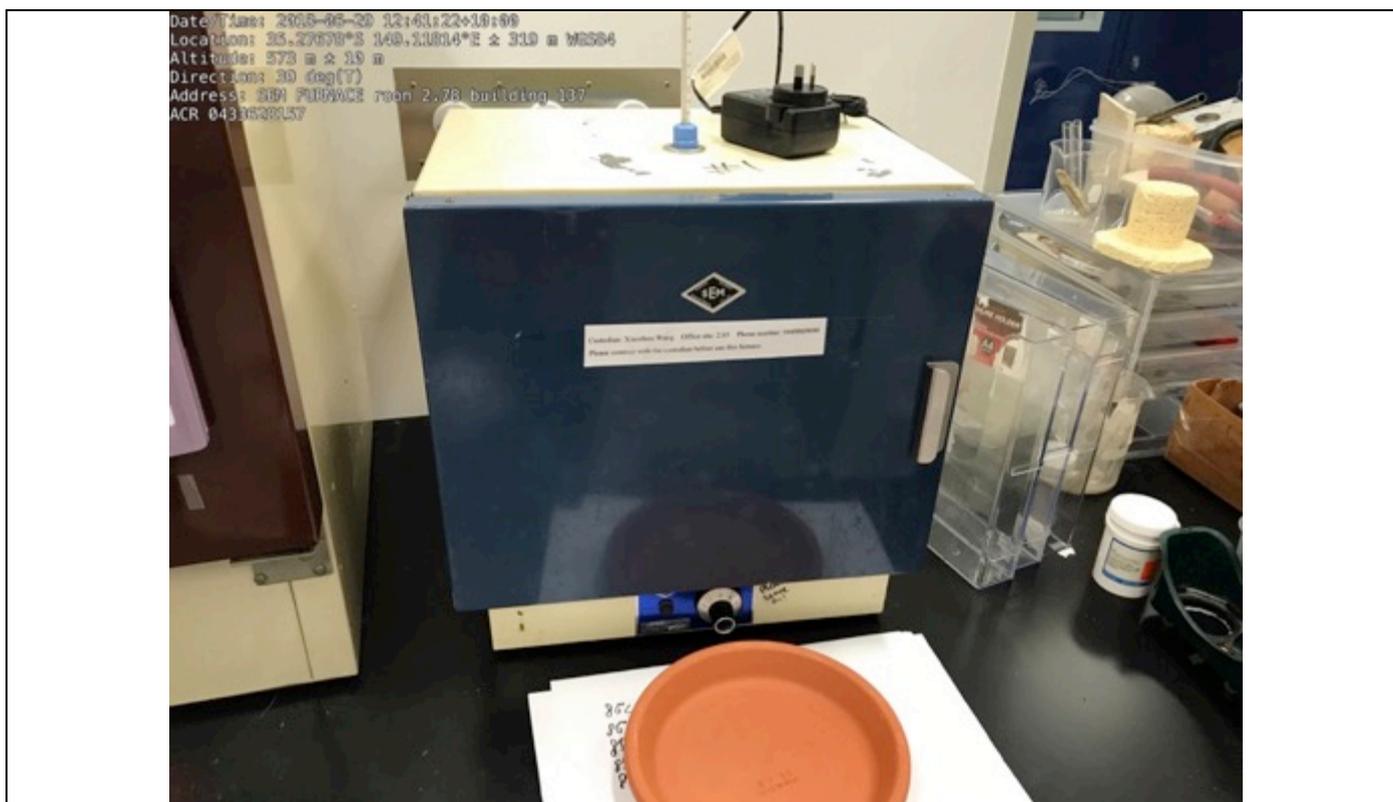
Room 2.78	SEM Furnace	-	Good	Visual	3
-----------	-------------	---	------	--------	---

Room 2.78 (cont)	SEM furnace	-	Good	Visual	3	Yes	<p>No visual ACMs present during standard usage.</p> <p>Due to the age & type of equipment it should be assumed that ACMs are present in the unit.</p> <p>Any personnel conducting repairs or maintenance should be aware that ACMs might be present.</p> <p>No works on the equipment is to proceed if it is suspected it will disturb the possible ACMs, equipment should be tagged out & disposed of accordingly by a Licensed Professional</p>
	LABEC Tube furnace Fume cabinet L2-43		Good	Visual	3	Yes	<p>No visual ACMs present during standard usage.</p> <p>Due to the age & type of equipment it should be assumed that ACMs are present in the unit.</p> <p>Any personnel conducting repairs or maintenance should be aware that ACMs might be present.</p> <p>No works on the equipment is to proceed if it is suspected it will disturb the possible ACMs, equipment should be tagged out & disposed of accordingly by a Licensed Professional</p>

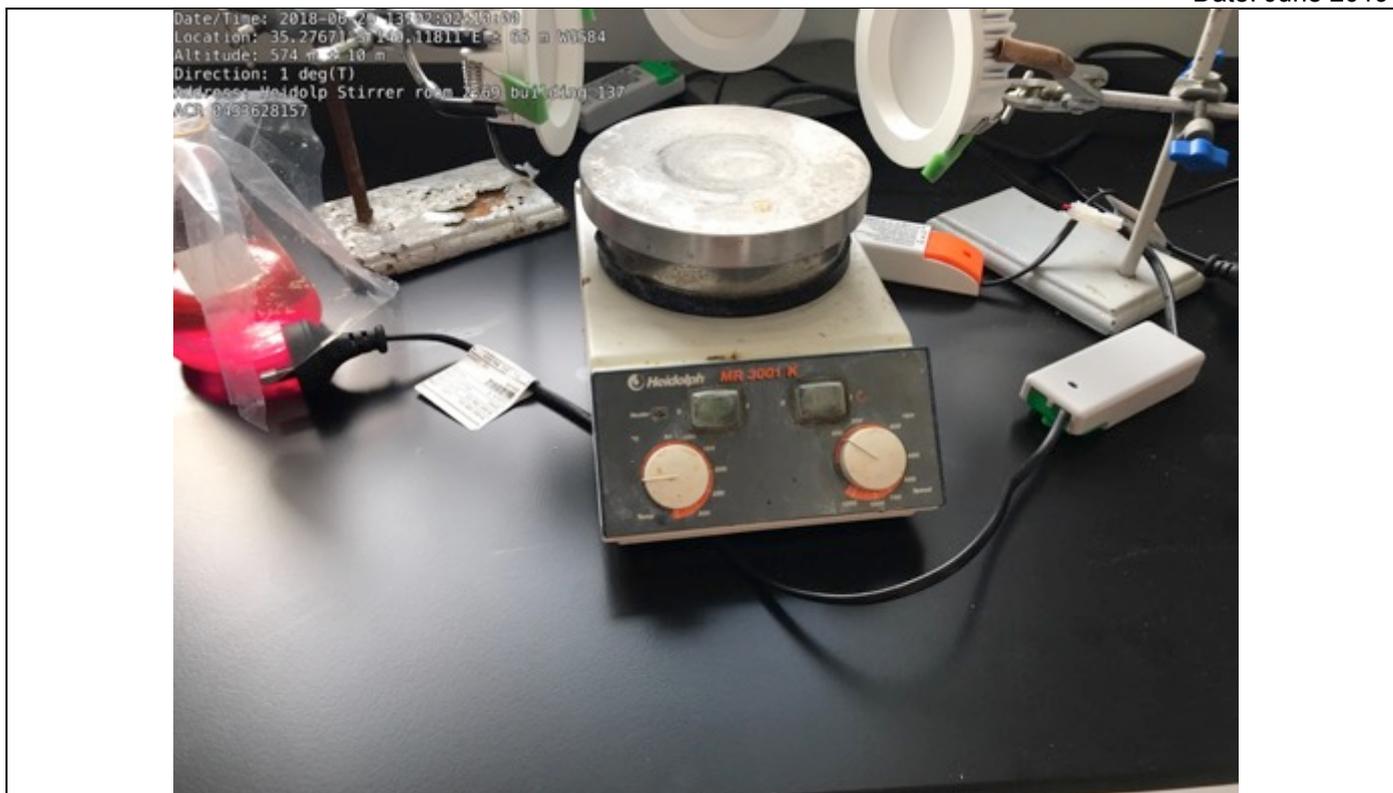
Date/Time: 2018-06-20 13:32:02+10:00
 Location: 35.27671°S 149.11811°E ± 65 m WGS84
 Altitude: 574 m ± 10 m
 Direction: 1 deg(T)
 Address: Heidolph Stirrer room 2.69 building 137
 ACR 0433628157

Room 2.69	Heidolph Heater Stirrer	-	Good	Visual	3
-----------	-------------------------	---	------	--------	---

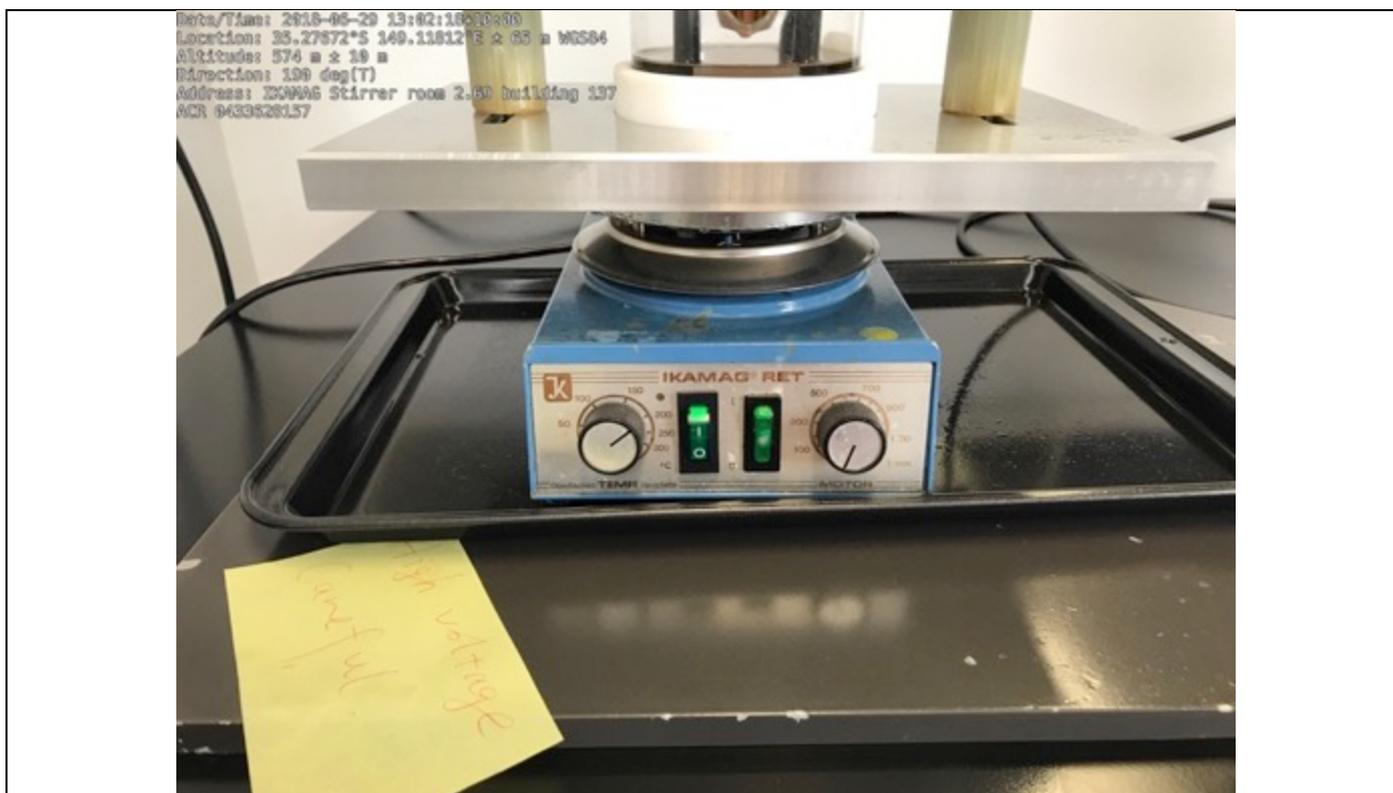
Date/Time: 2018-06-20 13:42:18+10:00
 Location: 35.27672°S 149.11812°E ± 65 m WGS84
 Altitude: 574 m ± 10 m
 Direction: 199 deg(T)
 Address: IKA Stirrer room 2.69 building 137
 ACR 0433628157

Room 2.69	IKA Heater Stirrer	-	Good	Visual	3
-----------	--------------------	---	------	--------	---

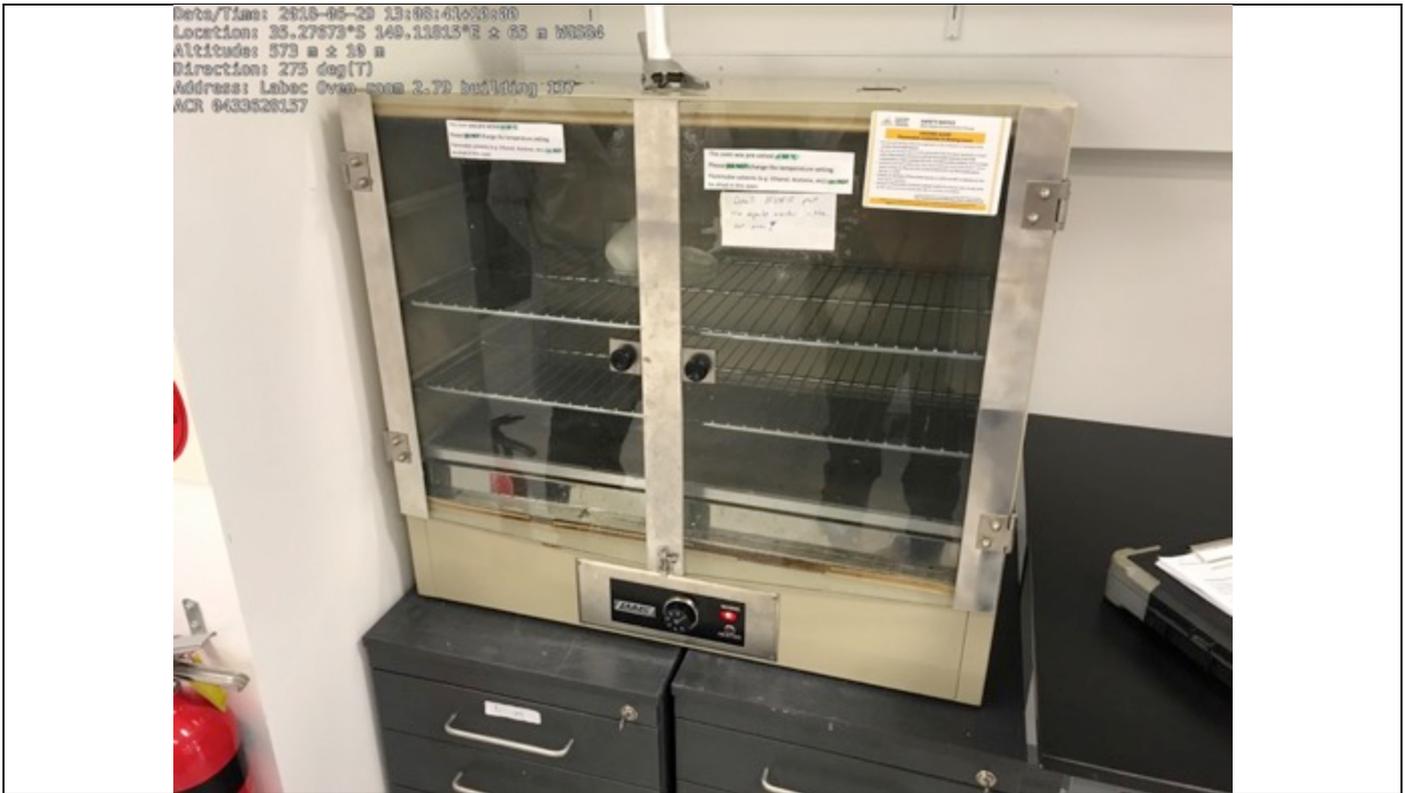
Room 2.79	Labec Heating Oven	-	Good	Visual	3
-----------	--------------------	---	------	--------	---

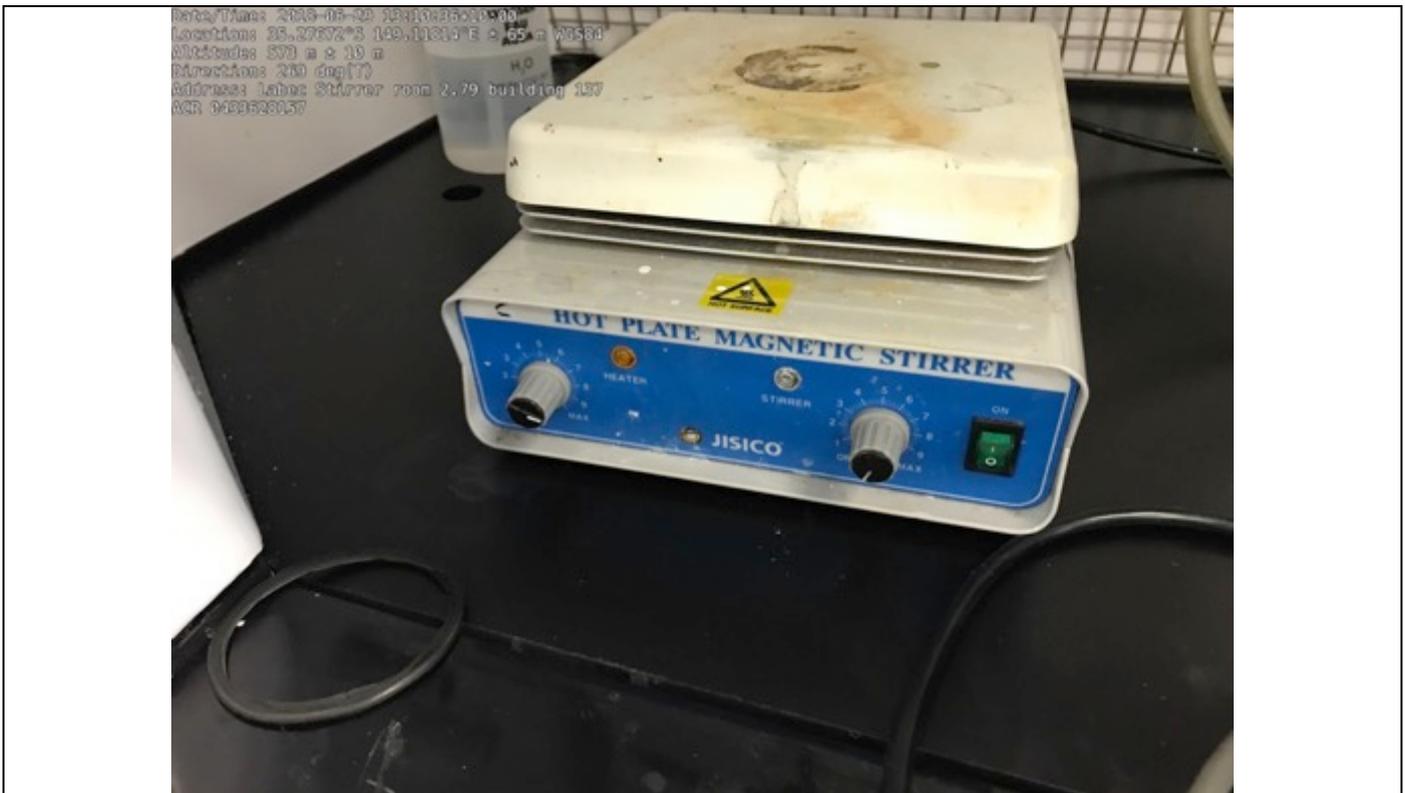
Room 2.79	Labec Heater Stirrer	-	Good	Visual	3
-----------	----------------------	---	------	--------	---

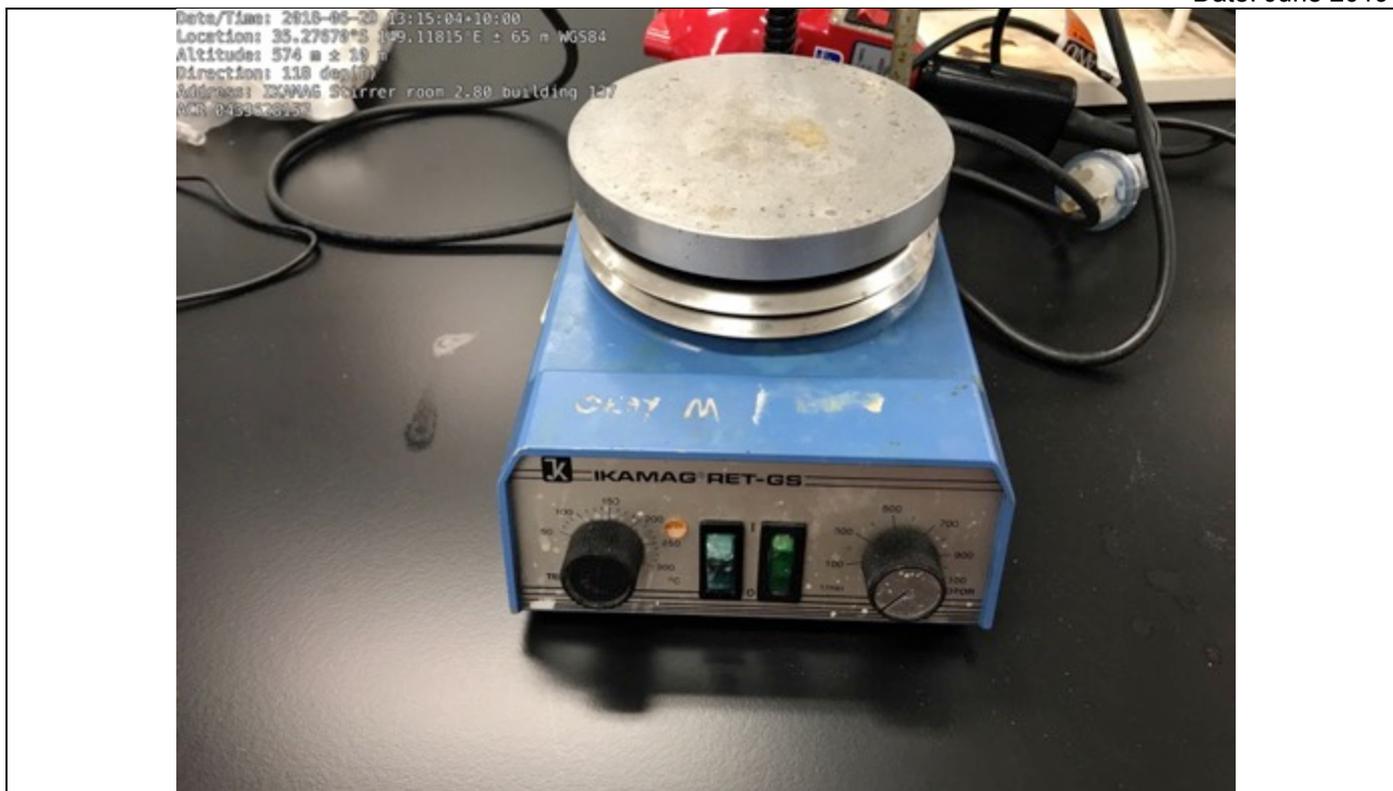
Date/Time: 2018-06-29 13:15:04+10:00
 Location: 35.27679°S 149.11815°E ± 65 m WGS84
 Altitude: 574 m ± 10 m
 Direction: 118 deg(T)
 Address: IKAMAG Stirrer room 2.80 building 127
 ACR 0459528157

Room 2.80	IKA Heater Stirrer	-	Good	Visual	3
-----------	--------------------	---	------	--------	---

Room 2.80	IKA Heater Stirrer	682881	Good	Visual	3	Yes	<p>No visual ACMs present during standard usage.</p> <p>Due to the age & type of equipment it should be assumed that ACMs are present in the unit.</p> <p>Any personnel conducting repairs or maintenance should be aware that ACMs might be present.</p> <p>No works on the equipment is to proceed if it is suspected it will disturb the possible ACMs, equipment should be tagged out & disposed of accordingly by a Licensed Professional</p>
	IKA Heater Stirrer	0533445	Good	Visual	3	Yes	<p>No visual ACMs present during standard usage.</p> <p>Due to the age & type of equipment it should be assumed that ACMs are present in the unit.</p> <p>Any personnel conducting repairs or maintenance should be aware that ACMs might be present.</p> <p>No works on the equipment is to proceed if it is suspected it will disturb the possible ACMs, equipment should be tagged out & disposed of accordingly by a Licensed Professional</p>

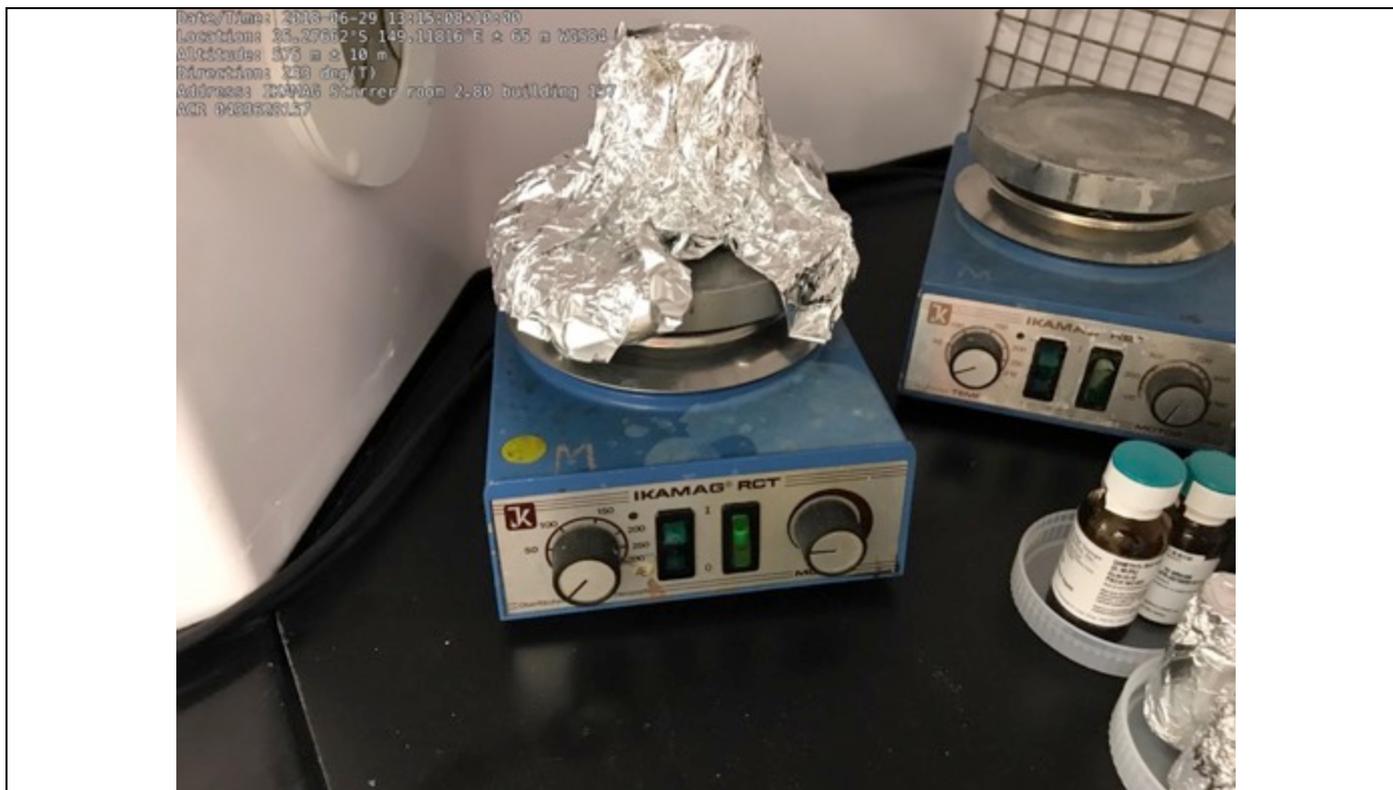
Date/Time: 2018-06-29 13:15:08+10:00
 Location: 35.27682°S 149.11816°E ± 65 m WGS84
 Altitude: 575 m ± 10 m
 Direction: 120 deg(T)
 Address: IKAMAG Stirrer room 2.80 building 127
 ACR 0459528157

Room 2.80	IKA Heater Stirrer	-	Good	Visual	3
-----------	--------------------	---	------	--------	---

IKA Heater Stirrer	0476086	Good	Visual	3	Yes	<p>No visual ACMs present during standard usage.</p> <p>Due to the age & type of equipment it should be assumed that ACMs are present in the unit.</p> <p>Any personnel conducting repairs or maintenance should be aware that ACMs might be present.</p> <p>No works on the equipment is to proceed if it is suspected it will disturb the possible ACMs, equipment should be tagged out & disposed of accordingly by a Licensed Professional</p>
Room 1.90	IKA Heater Stirrer	0533426	Good	Visual	3	Yes	<p>No visual ACMs present during standard usage.</p> <p>Due to the age & type of equipment it should be assumed that ACMs are present in the unit.</p> <p>Any personnel conducting repairs or maintenance should be aware that ACMs might be present.</p> <p>No works on the equipment is to proceed if it is suspected it will disturb the possible ACMs, equipment should be tagged out & disposed of accordingly by a Licensed Professional</p>

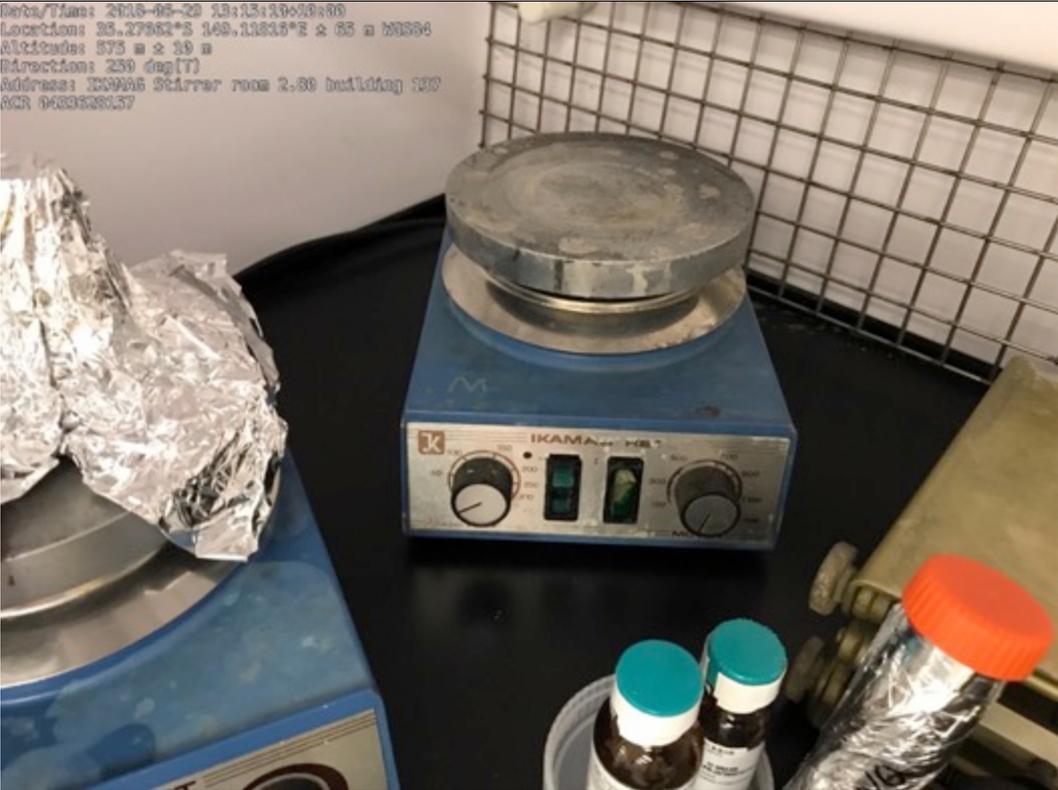
<p>Data/Time: 2018-05-20 13:13:10+10:00 Location: 35.27662°S 149.11815°E ± 65 m WGS84 Altitude: 575 m ± 10 m Direction: 259 deg(T) Address: IKAHE Stirrer room 2.80 building 137 ACR 0433520157</p>					
Room 2.80	IKA Heater Stirrer	-	Good	Visual	3

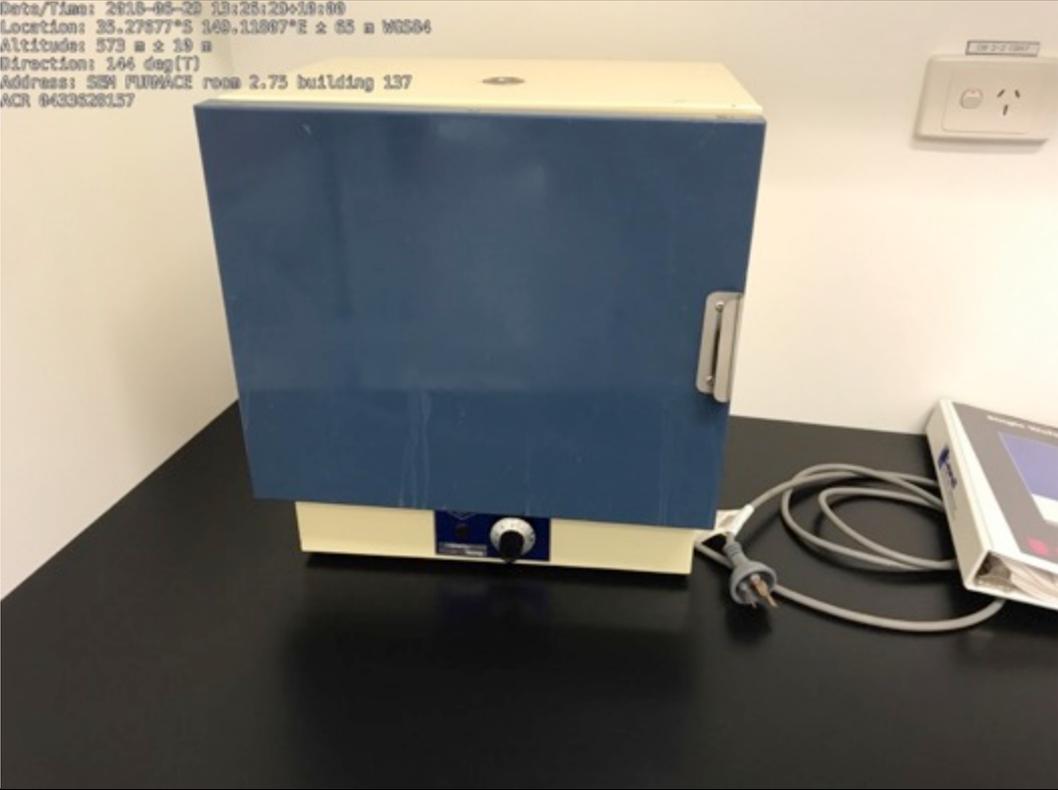
<p>Data/Time: 2018-05-20 13:25:20+10:00 Location: 35.27677°S 149.11807°E ± 65 m WGS84 Altitude: 573 m ± 10 m Direction: 144 deg(T) Address: SEM FURNACE room 2.75 building 137 ACR 0433520157</p>					
Room 2.75	SEM Furnace	-	Good	Visual	3

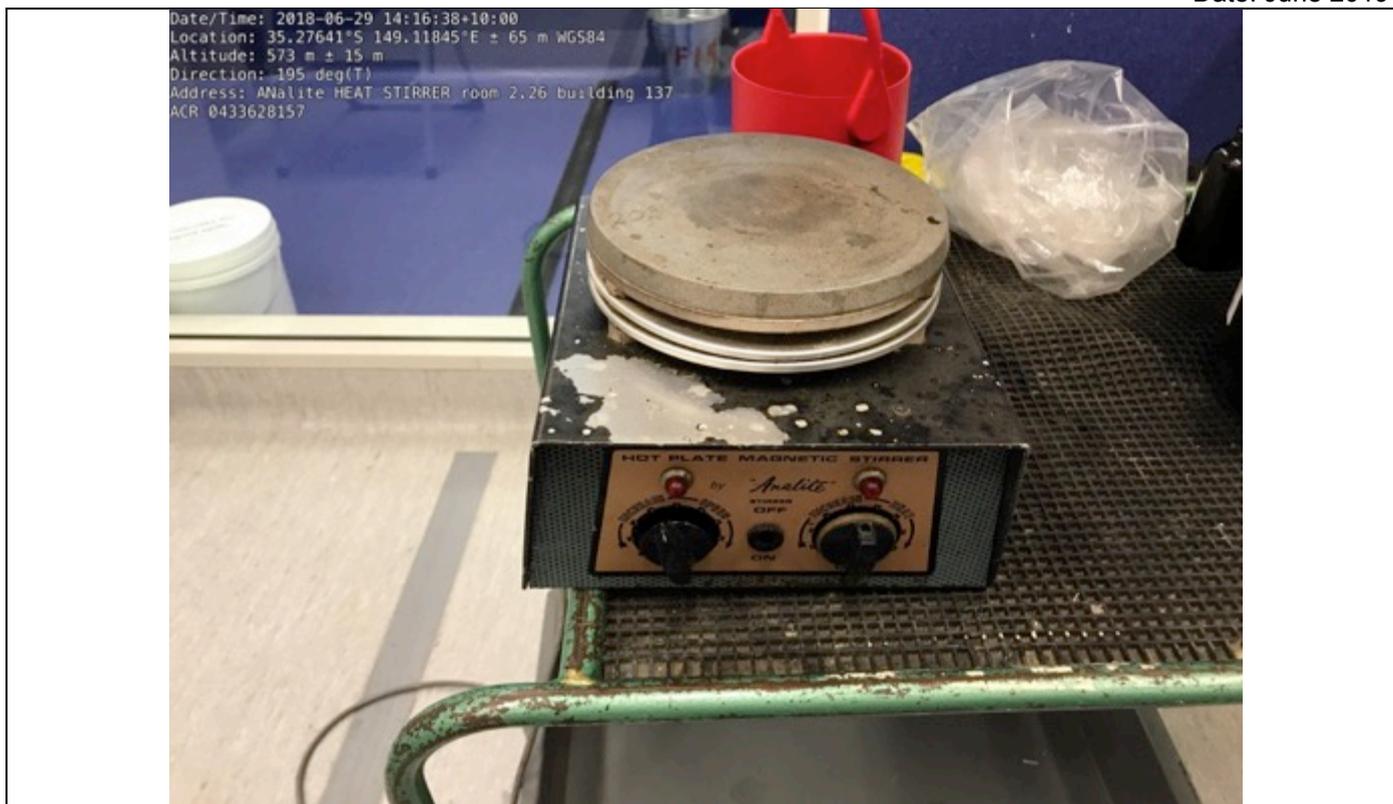
Date/Time: 2018-06-29 14:16:38+10:00
 Location: 35.27641°S 149.11845°E ± 65 m WGS84
 Altitude: 573 m ± 15 m
 Direction: 195 deg(T)
 Address: Analite HEAT STIRRER room 2.26 building 137
 ACR 0433628157

Room 2.26	Analite Heater Stirrer	-	Good	Visual	3
-----------	------------------------	---	------	--------	---
