Equipment Report

Report No :		ACR190219-01 Rev1	
Address:		Research School of Chemistry ANU	
Prepared & Approved By :		B.Williams LAA000169

Date:		June 2019	
Re-inspection Due		June 2020

ACR was engaged to undertake an inspection of equipment at the Research School of Chemistry ANU that was suspected to have asbestos containing materials present.

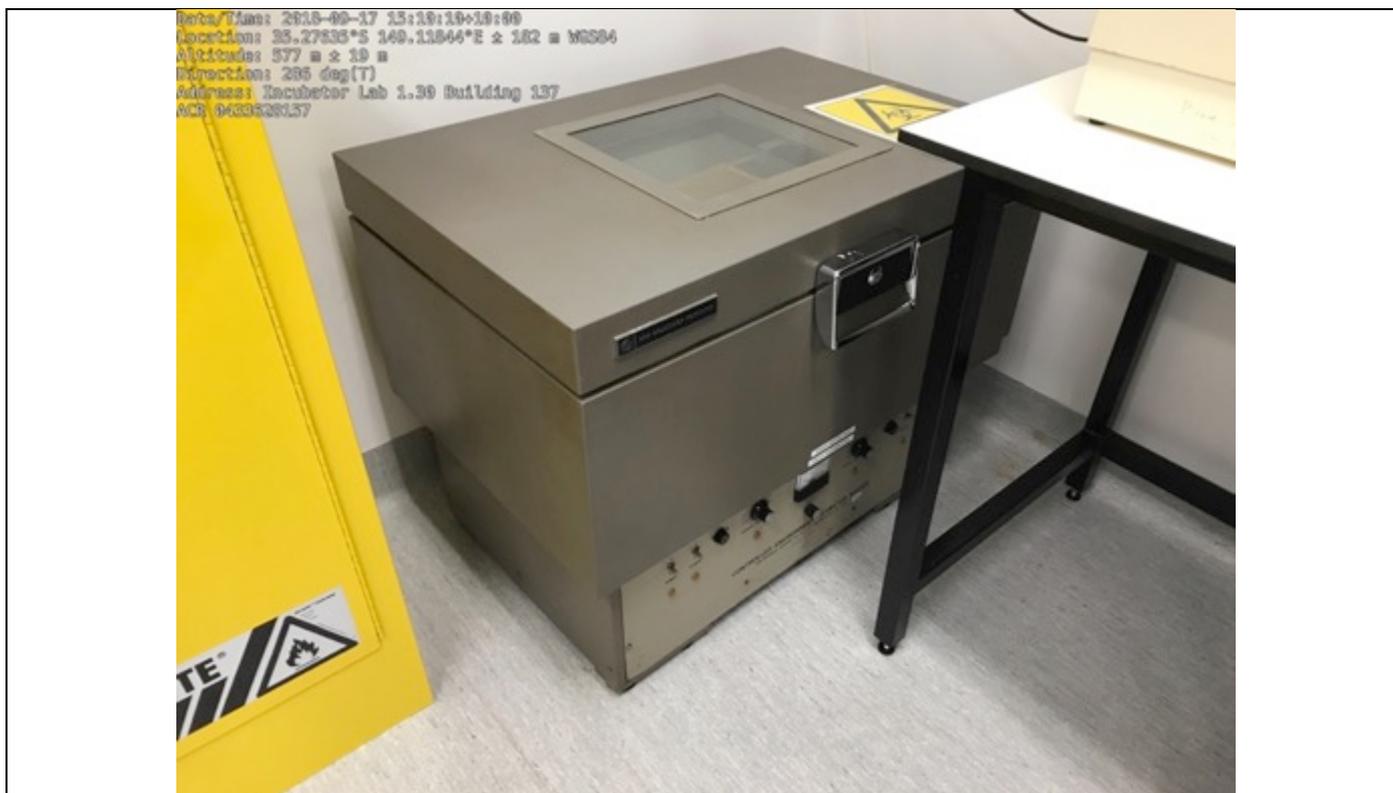
Date/Time: 2018-09-17 15:18:18+10:00
 Location: 35.27635°S 149.11844°E ± 182 m WGS84
 Altitude: 577 m ± 19 m
 Direction: 285 deg(T)
 Address: Incubator Lab 1.39 Building 137
 ACR 0433628157

Room 1.39	Incubator	-	Good	Visual	3
-----------	-----------	---	------	--------	---

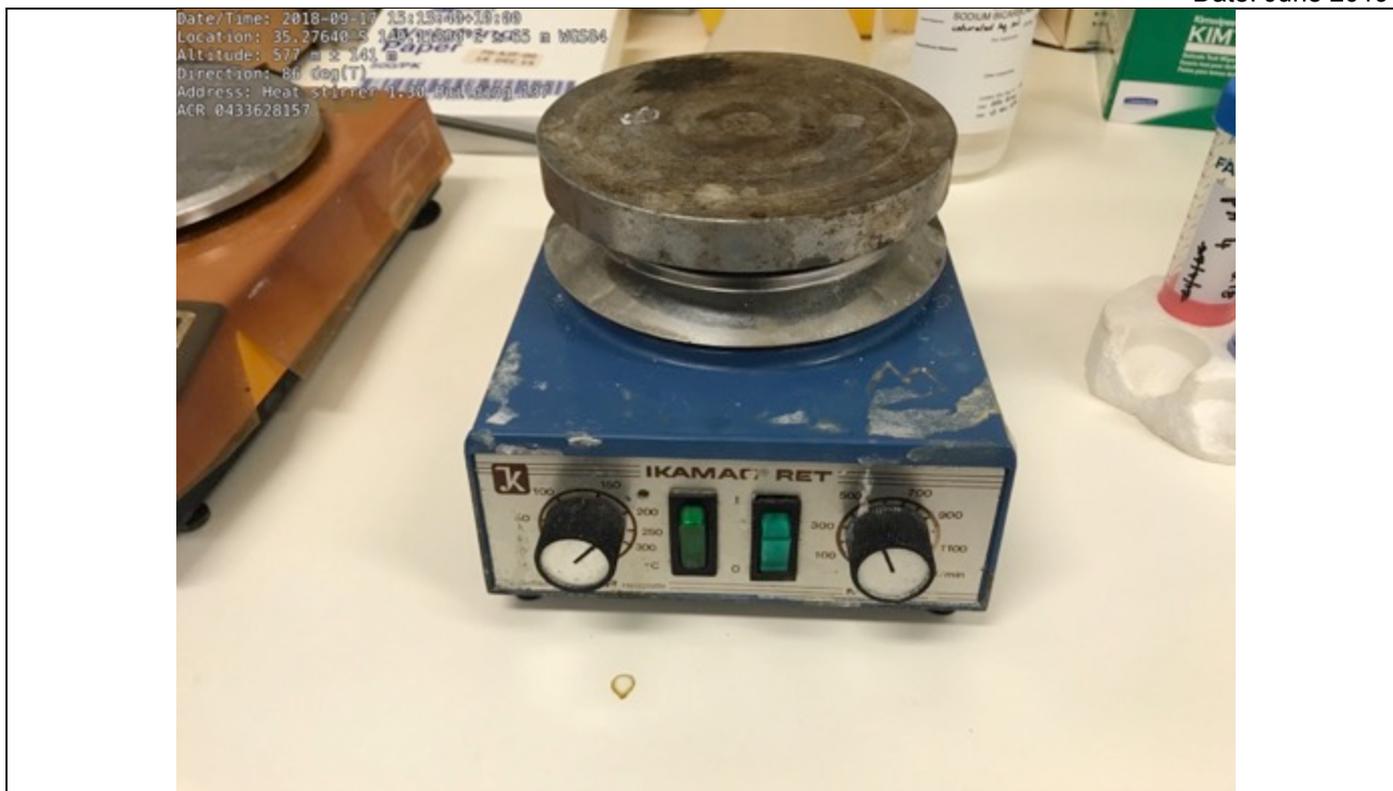
Room 1.30	IKA Heater Stirrer	-	Good	Visual	3
-----------	--------------------	---	------	--------	---

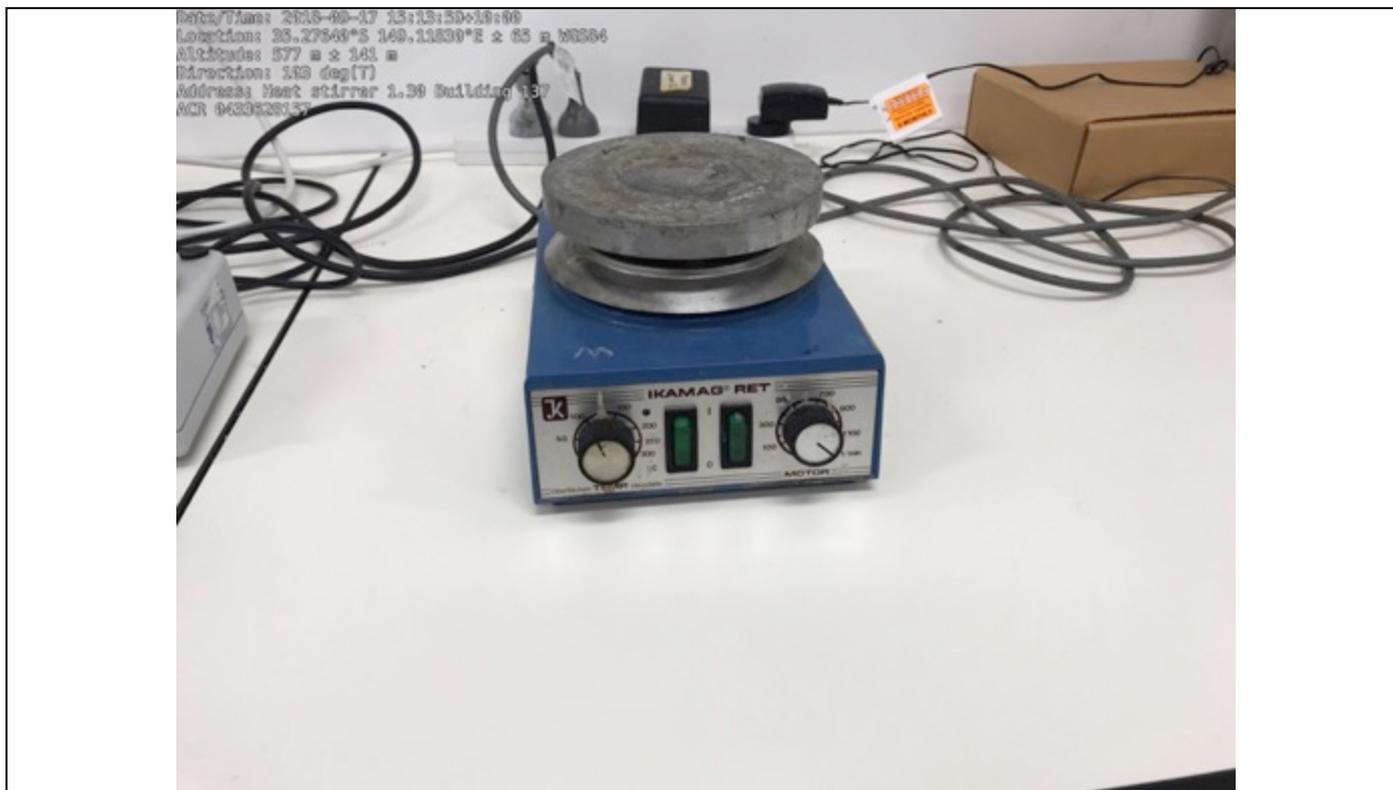
Room 1.39	IKA Heater Stirrer	-	Good	Visual	3
-----------	--------------------	---	------	--------	---

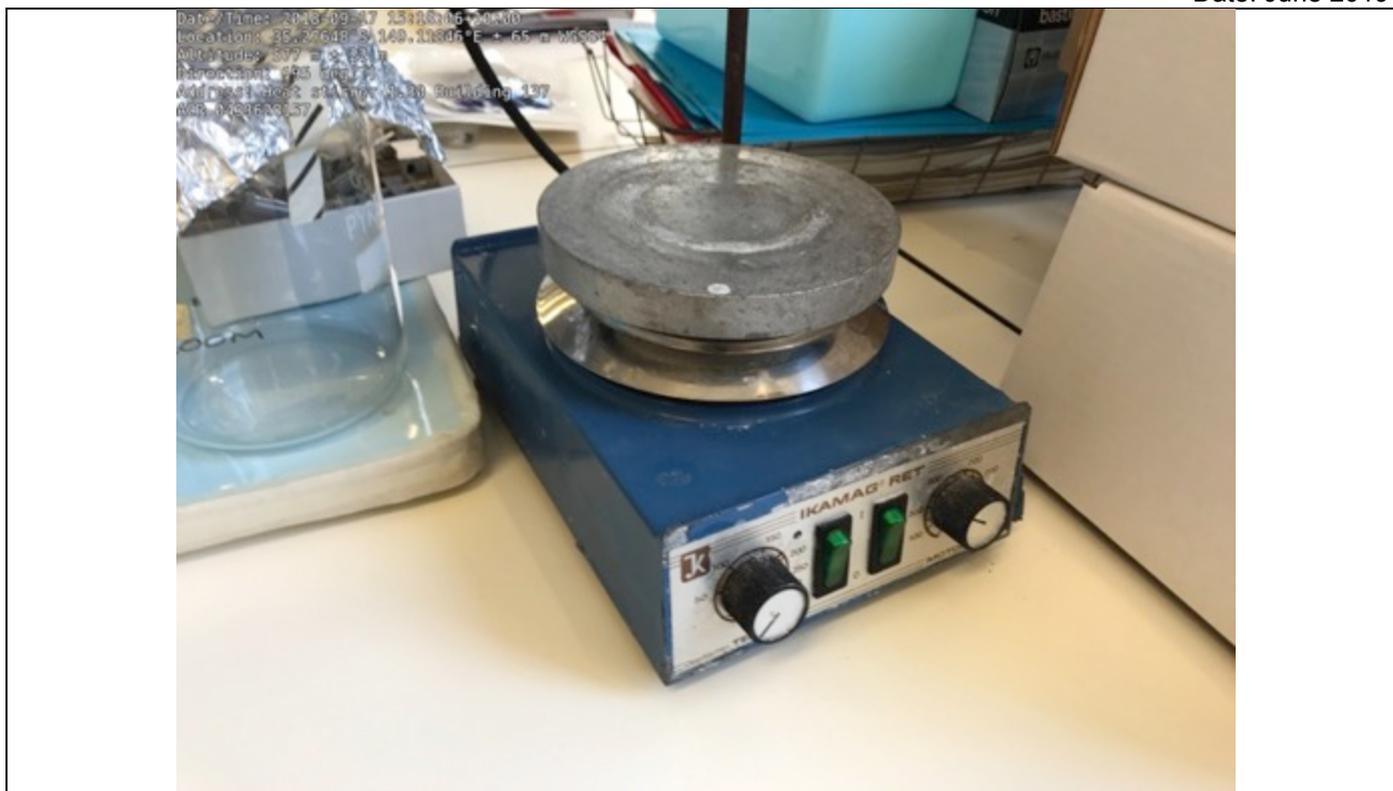
Room 1.38	IKA Heater Stirrer	-	Good	Visual	3
-----------	--------------------	---	------	--------	---

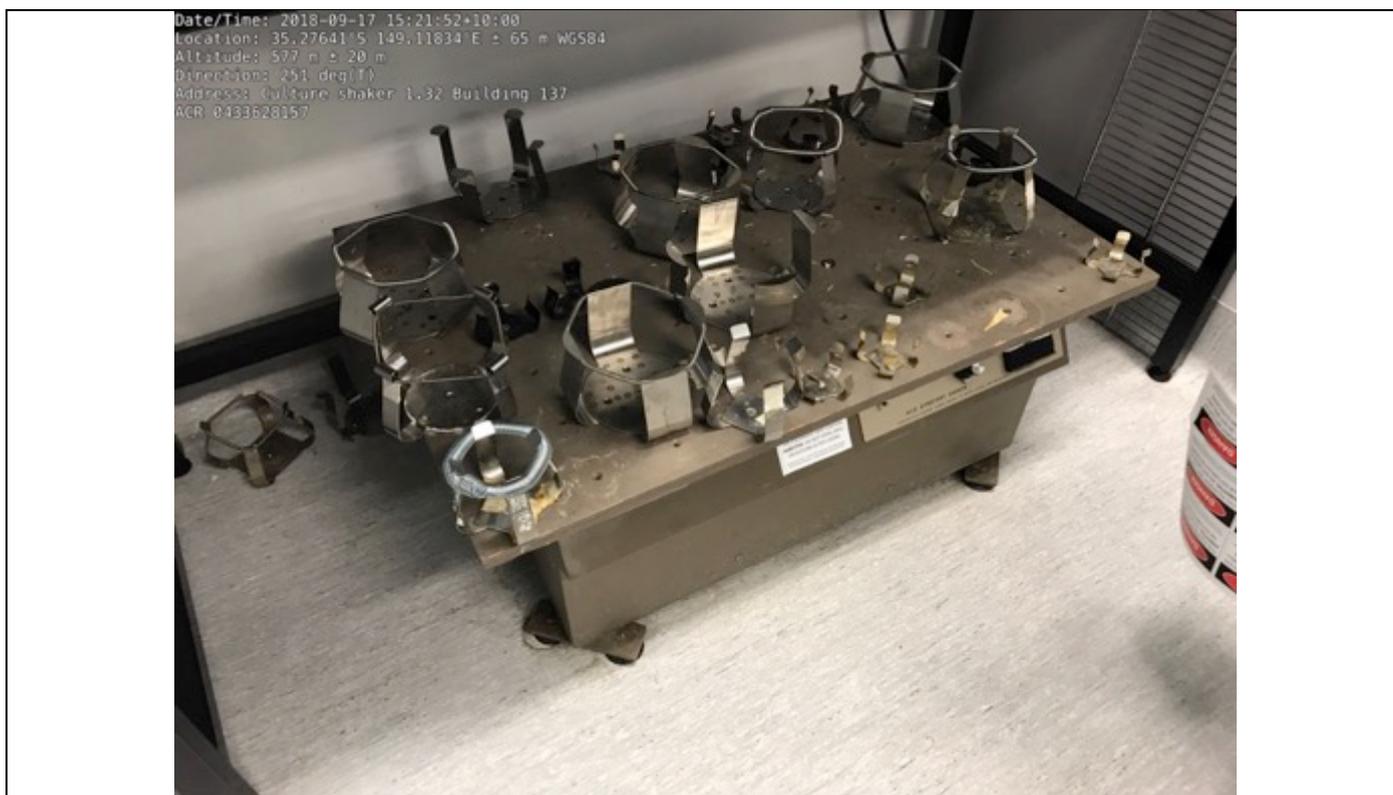
Room 1.32	Culture Shaker	-	Good	Visual	3
-----------	----------------	---	------	--------	---
